# Kan Limfjordstunnelen reddes

# Kan Limfjordstunnelen reddes?

# Structural Expert Group 2018-2019

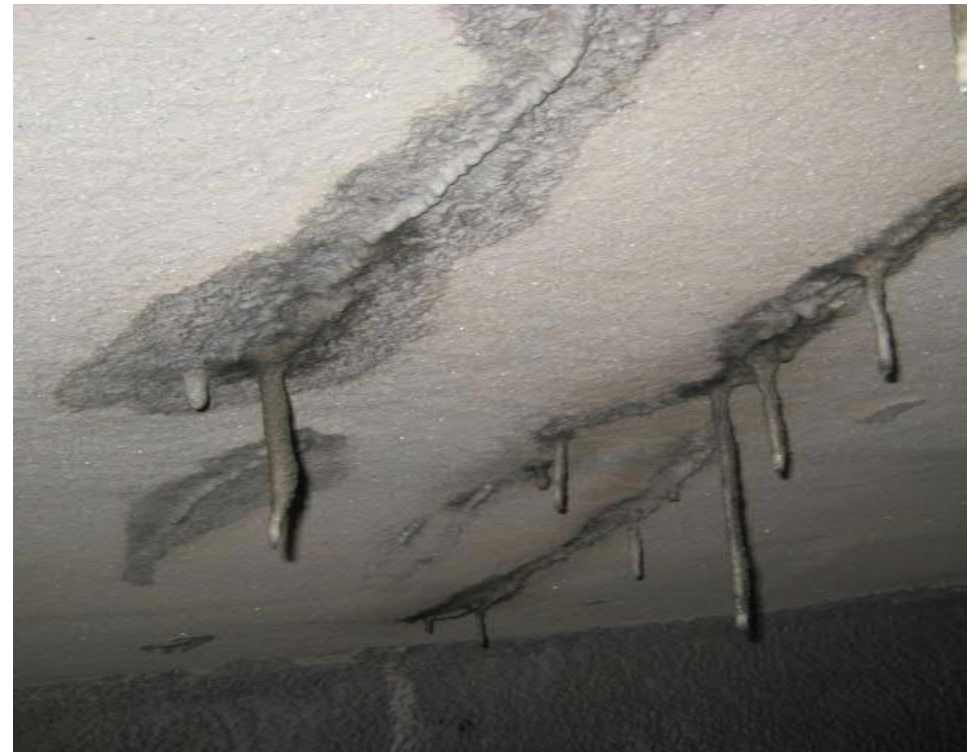
## Waterproofing has been carried out frequently

- The tunnel is waterproofed with an outer rubber membrane under protective concrete and stone casing, but this has been depleted since commissioning.
- From the beginning, cracks and leaks were found in the concrete - especially at the construction joints.
- In the 1970s and 80's many seals and repairs were done and tested different solutions.
- An important task has been carried out in communicating to the public that the tunnel is safe - despite the fact that salt water enters the tunnel.

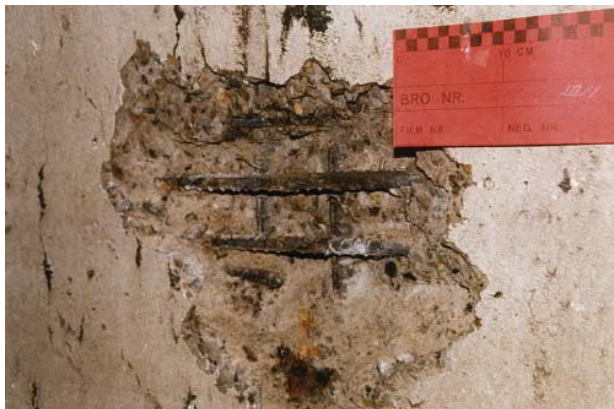
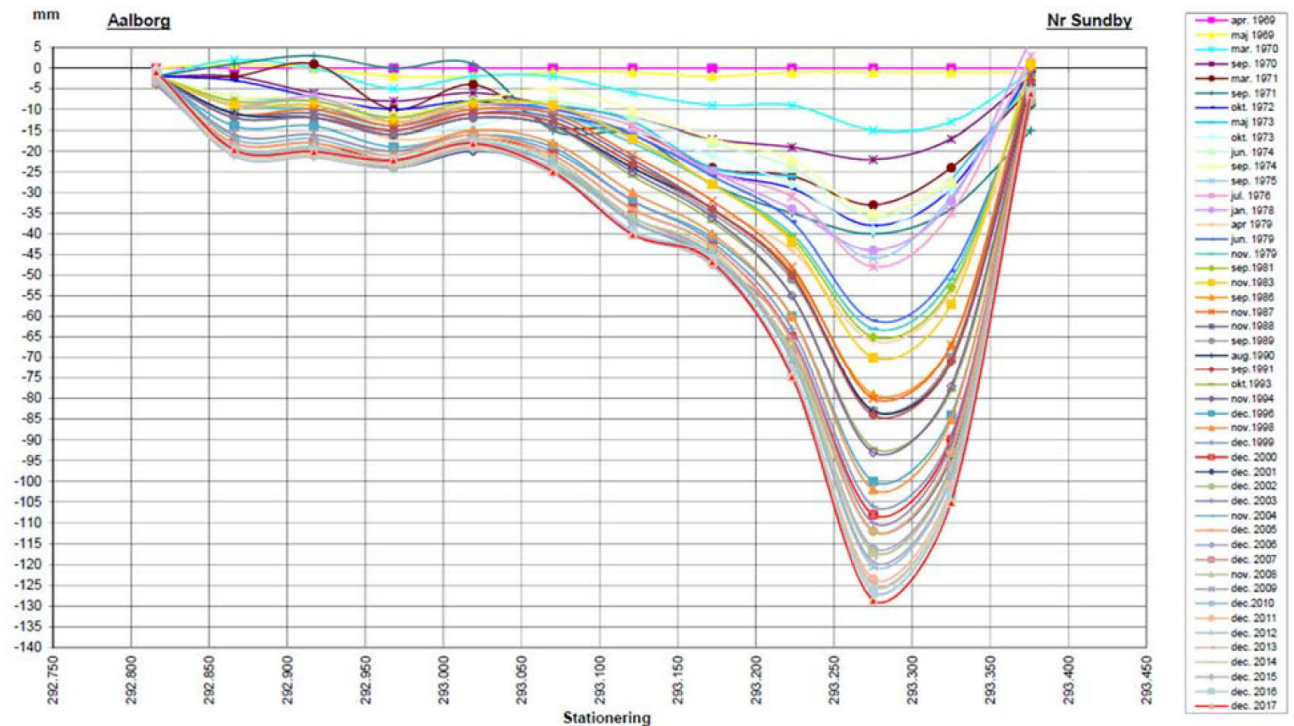
- Water-proofing membrane.
- Cracks in the tunnel roof and outer walls.
- Settlements of the tunnel.
- Corrosion of the reinforcement.
- Post-tensioning cables installed in 1993-94.
- Reinforcement and concrete repair late 1990's.
- Anchors repair due to delamination in 2010.

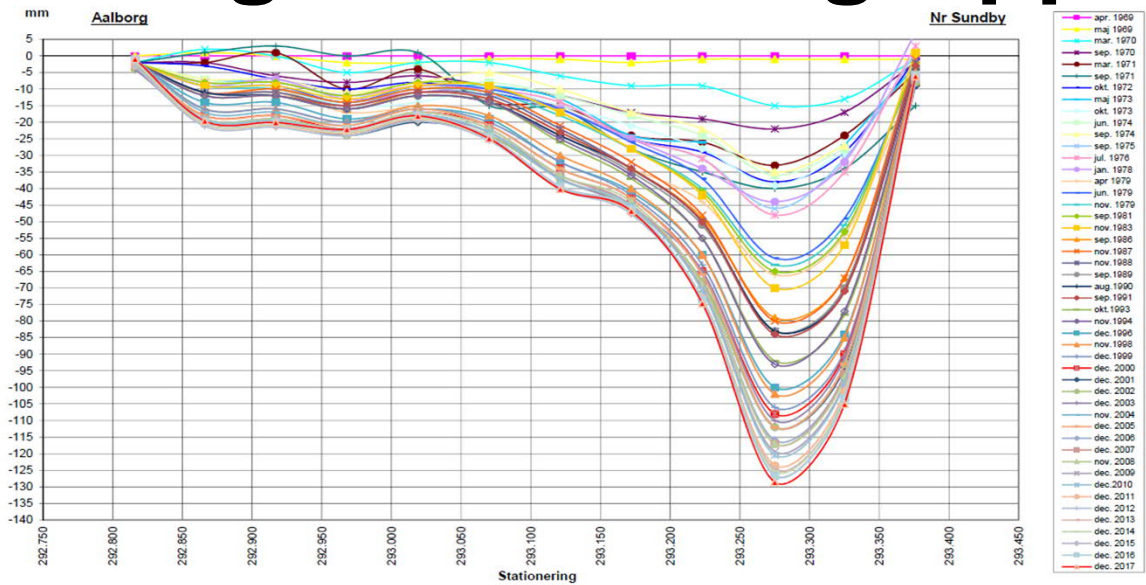
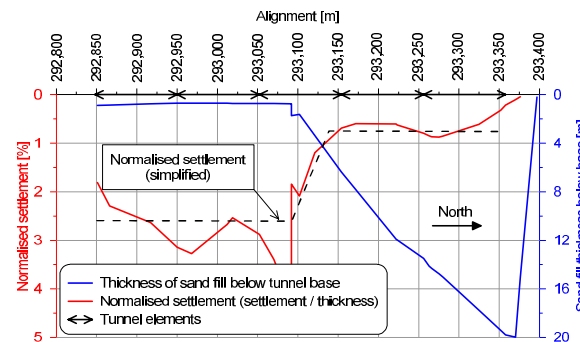
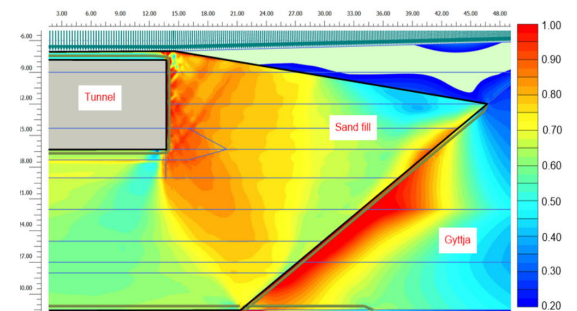
Defect:

- Large settlement at TE-IV & TE-V

130mm (2017)

190mm (2067) prediction

Cause:

- Creep settlement of Sand Fill (Interaction with Gytja deposits on each side of tunnel cross section)

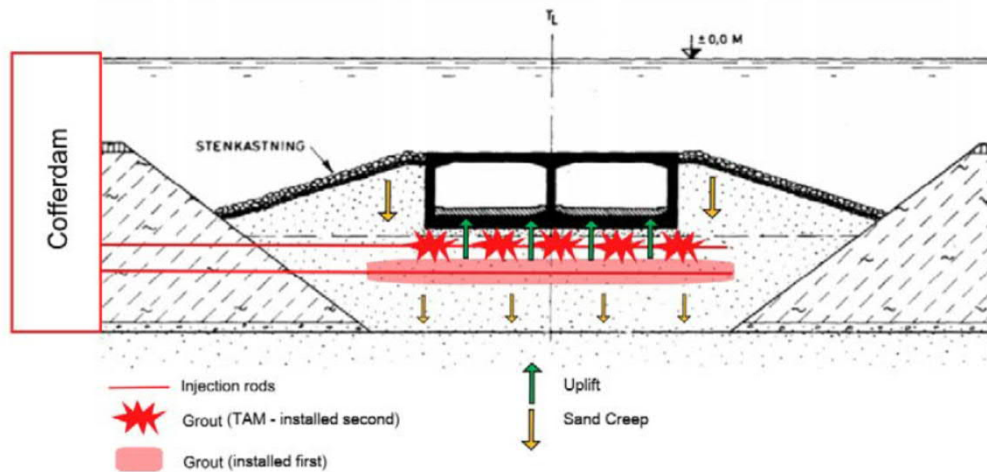
Figure 9.2-3 Section showing indicative pre-treatment and compensation grout injection tubes.

1. Additional prestressing (year 2035)
2. Replace bearing blocks (year 2045)
3. Active horizontal compensation grouting (year 2064)

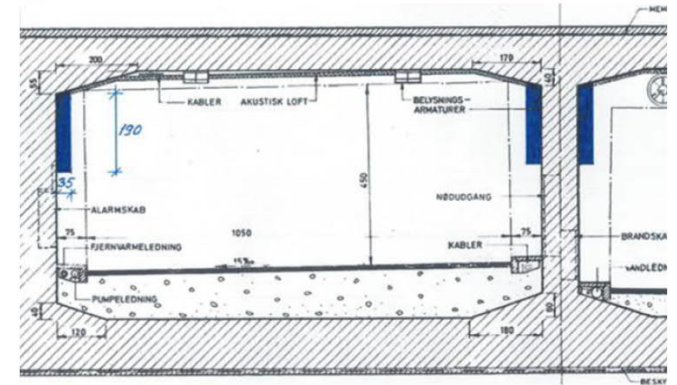
Figure 9.3-1 Spaces available for installations such as external post tensioning cables (blue colour) along upper part of all wall surfaces.

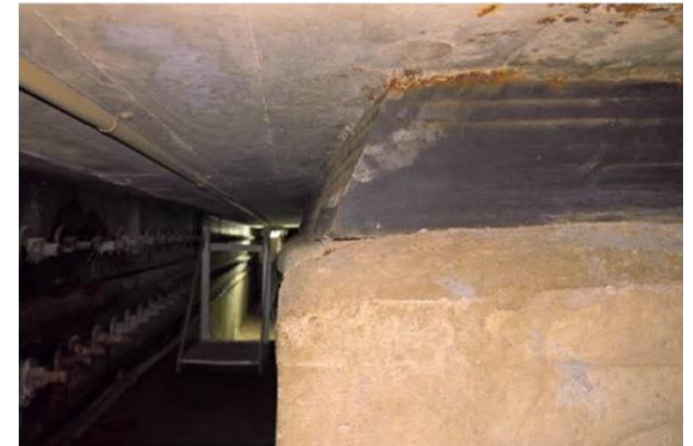
4.1-3 Elastomeric bearing at the northern portal building.

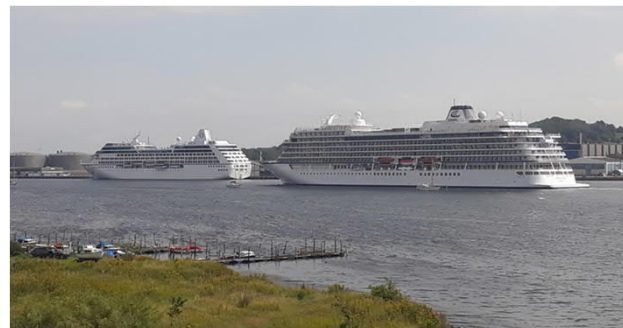
- Preliminary ship accident risk analysis
  - Sunken Ship (ok)
  - Grounding Ship
  - Dropped Anchor (ok)
  - Dragged Anchor (ok)
- Recommend: Detailed evaluation of possible protective structure and load from a grounding ship on TE-V
