# Kan Limfjordstunnelen reddes

# Kan Limfjordstunnelen reddes?

# Structural Expert Group 2018-2019

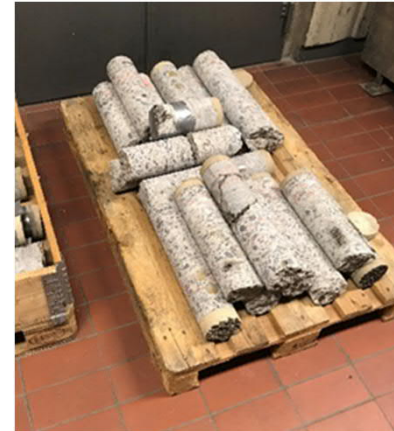
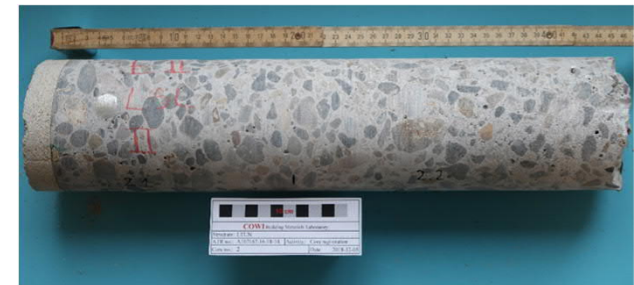
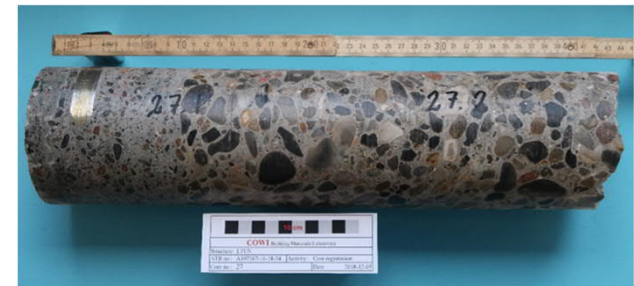
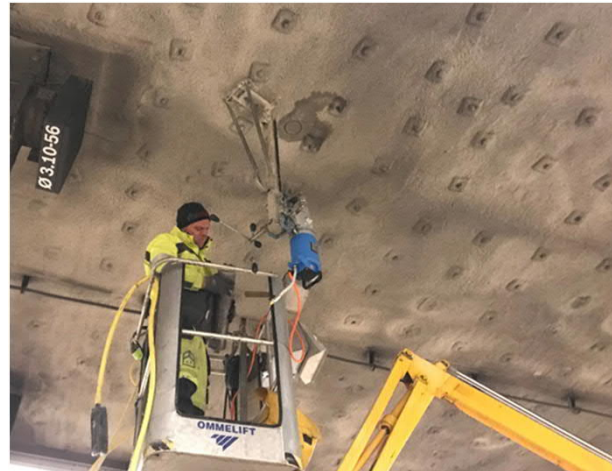
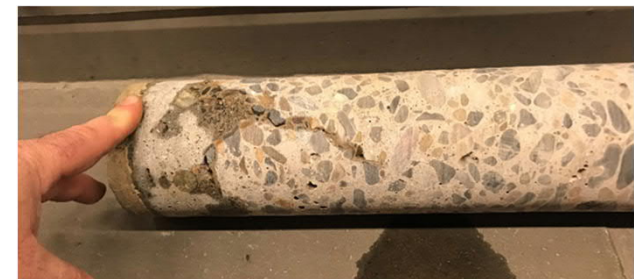
## Condition assessment – Investigations/sampling in situ

- 5 cores from external face of tunnel
  - macro analysis
  - chloride profiles
- Cores from inside tunnel (walls and roof)
  - 51 cores (macro analysis)
  - 43 for compression testing
  - chloride profiles
  - thin sections
- Non-destructive testing
  - HCP-measurements (to assess risk of corrosion)
  - Pundit (=ultrasonic pulse velocity and pulse echo testing)
  - Georadar (to locate rebars)
- 3 cores from bottom slab
  - macro analysis
  - micro analysis (4 thin sections)

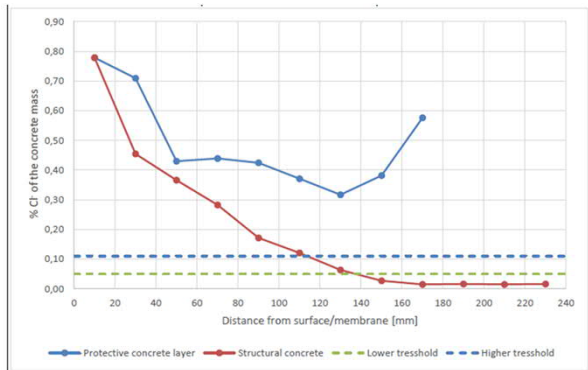
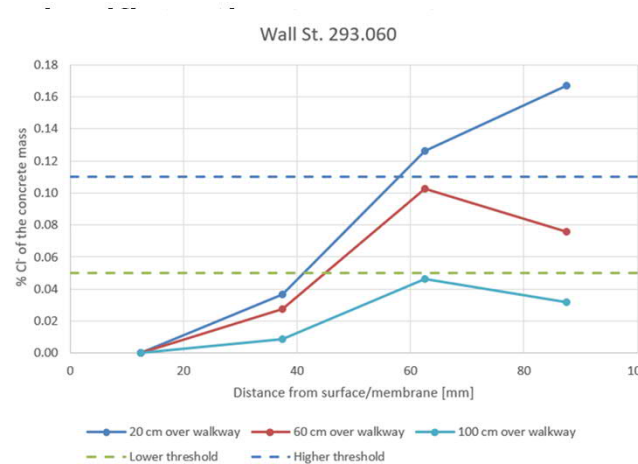
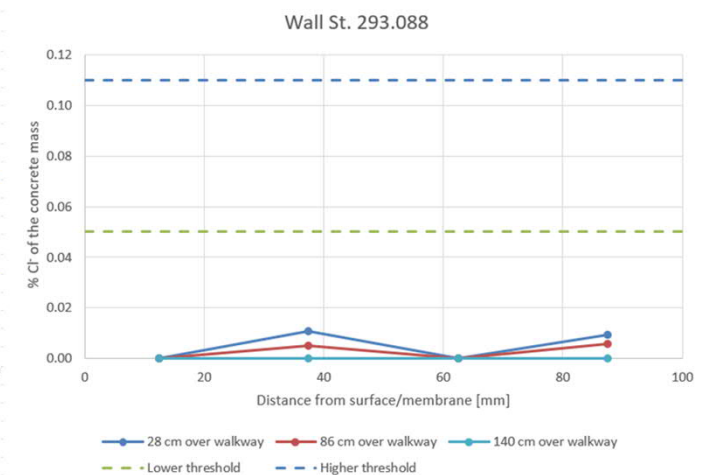
# Condition assessment - Concrete

- Compression tests

- Water content – see next slide

- Chloride content – varies very
